Analysis of Isolation Frame failure of a Screen for achieving optimum vibration

This article relates to a screen assembly for separating rock material, and more particularly to a modified vibrating screen that enhances the screen assembly's ability to resist cracking of the screen decks and side plates and prevents overall screen assembly failure and thereby enable increased vibration.

By
ASHISH BANERJEE AND SUDHIR KUMAR
 TRF Limited, Jamshedpur, INDIA

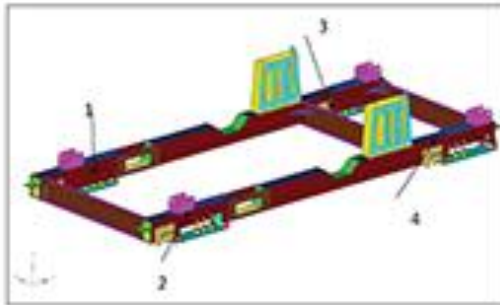
In this article we have studied and analyzed failure of isolation frame of a screen used in Europe by a steel manufacturing company. This isolation frame is supporting the main screen at four locations (1, 2, 3 & 4) as shown in the figure.

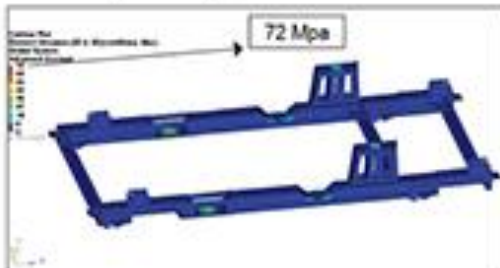
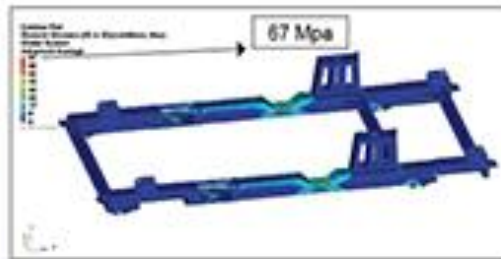
The results can be summarized as follows: If the screen works in the designed condition, the stress levels are reasonably low throughout the structure and failure is not likely to occur in line with figures 1 & 2 given below.

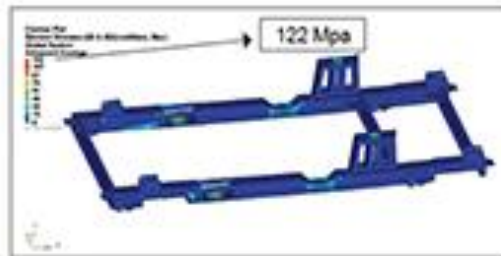
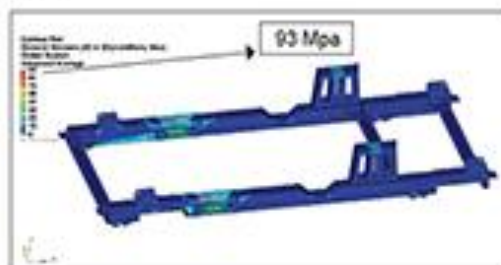
However, if one end of the spring is jammed by sand, a specific resonance is triggered that gives rise to stresses but within the limit as shown in figures 3 & 4 as compared with the yield stress of steel 250 Mpa.

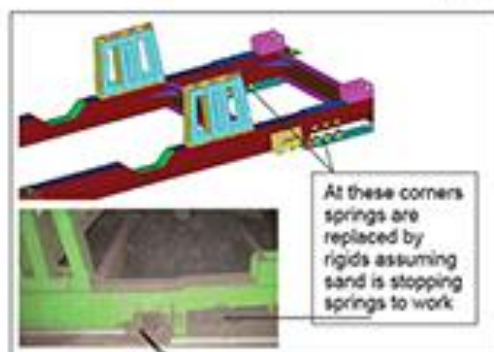
Fig. - 5

Actual condition of the machine has been shown in figure 5.

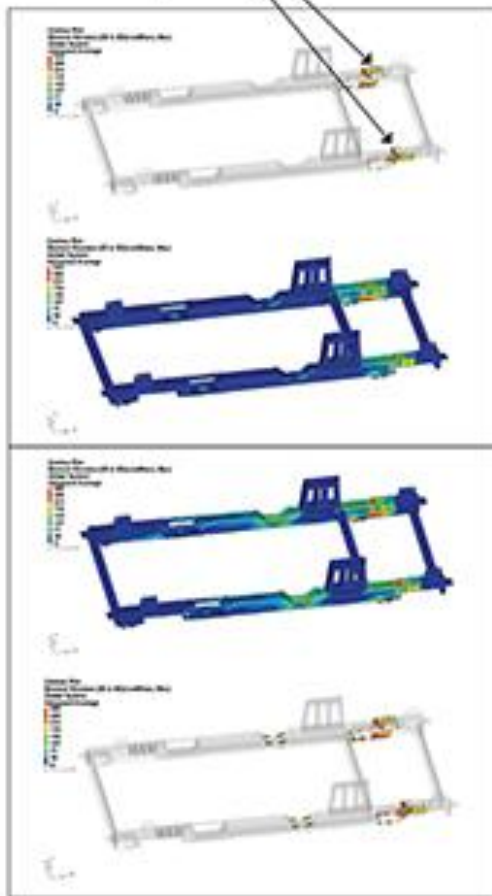
Fig. - 6

The high stress area matches the observed failure zone as indicated in the figure-6 below.

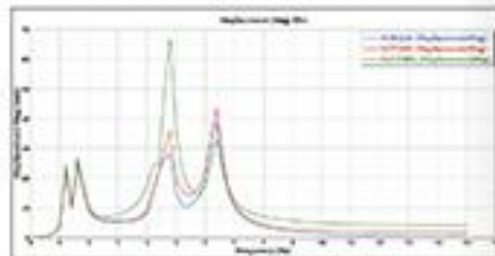
Fig. - 7

From the above graph, 1.2 Hz, 1.6 Hz, 4.8 Hz & 6.4 Hz frequencies are showing the resonance.

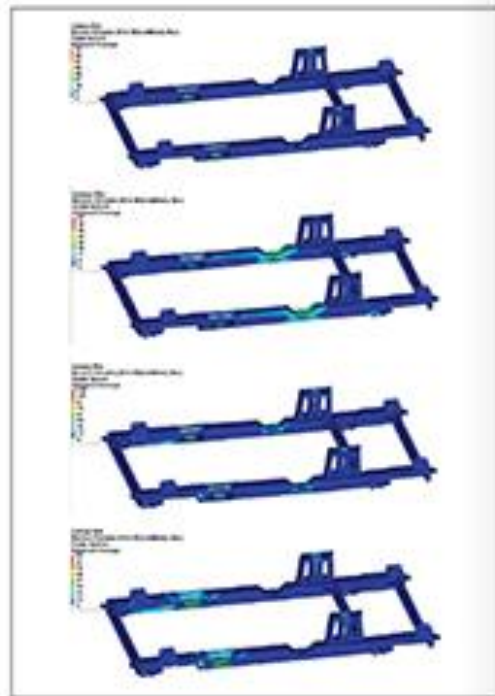
Fig. -8

The stresses at these frequencies are 25 Mpa, 60 Mpa, 60 Mpa & 50 Mpa respectively at the mid span of the frame (at screen spring location local stress can be neglected due to FE modeling assumption). The result shows that the stresses are well within the limit. (Refer figure 8).

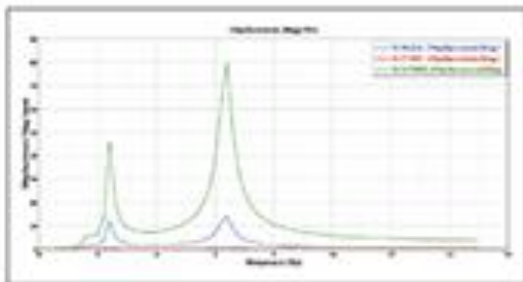
Fig. -9

From the above graph, 2.4 Hz & 6.4 Hz frequencies are resonant frequencies.

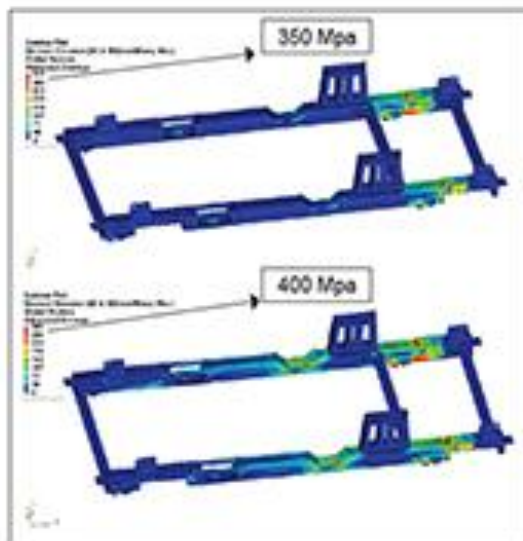
Fig. -10

The stresses at these frequencies are 350 Mpa & 400 Mpa respectively. Which is very high compared to the yield stress of the material and is likely to fail from its weakest part as indicated in the failed second mass frame (red zone, Figure-10)

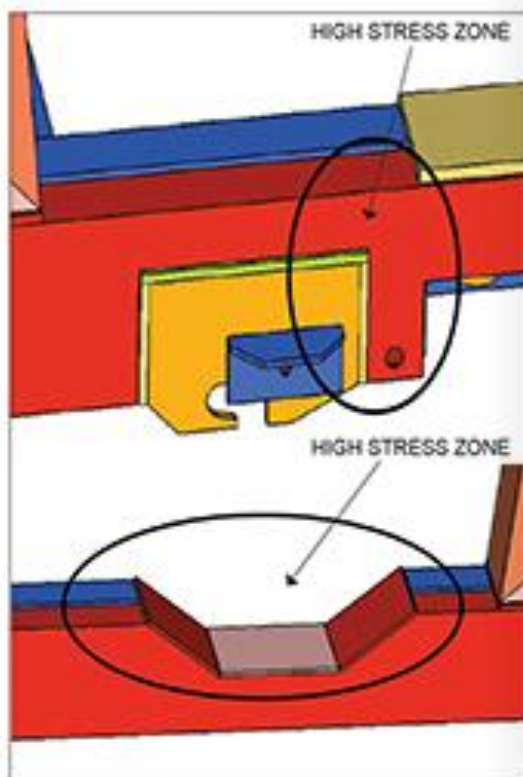
- The indicated areas are showing high stress zone in case of non-functioning of isolation frame due to sand accumulation on spring at two corners.
- From the frequency response results, it is validated that the region is too weak to sustain this condition.
- From the result, it is also clear that if all the springs function well then the structure is robust/stable enough to withstand specified loading condition.
- To overcome this problem, constant cleaning has been recommended beneath the spring and additional stiffener on isolation frame has been added through proper analysis of the modification.
