Analysis of Isolation Frame failure of a Screen for achieving optimum vibration

This article relates to a screen assembly for separating rock material, and more particularly to a modified vibrating screen that enhances the screen assembly's ability to resist cracking of the screen decks and side plates and prevents overall screen assembly failure and thereby enable increased vibration.

By
ASHISH BANERJEE AND SUDHIR KUMAR
 TRF Limited, Jamshedpur, INDIA

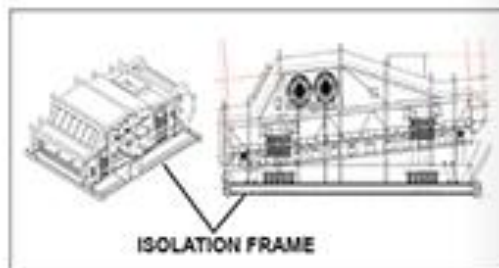
ISOLATION FRAME IN A SCREEN

In this article we have studied and analyzed failure of isolation frame of a screen used in Europe by a steel manufacturing company. This isolation frame is supporting the main screen at four locations (1, 2, 3 & 4) as shown in the figure.
